Inspector's Daily Report

IDR Sheet	1	of	1	Sheets	Final Record Book	Page	
Contract				Day		Date	
C-7852				Tuesday		August 17, 2010

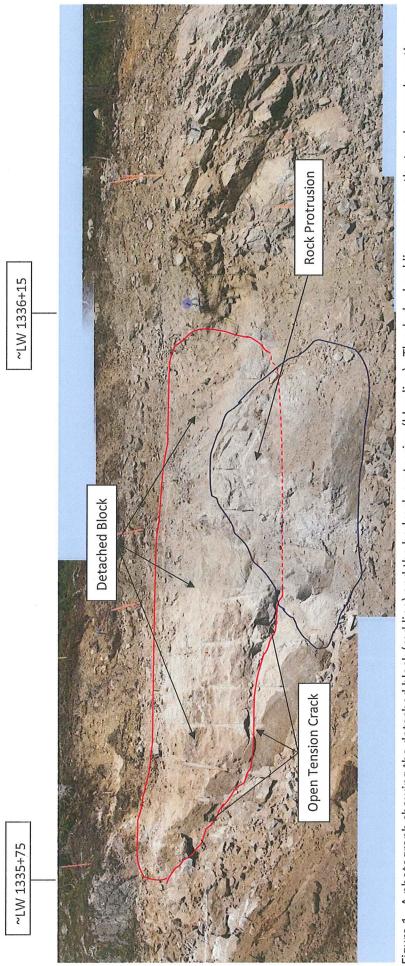
I met with Norm and Brad on-site to discuss the detached block located from approximate station LW 1335+75 to 1336+15. The detached block is approximately 40' long by 7' high by 4' thick (Figure 1). The west half of the block shifted down slope a couple of inches and a tension crack runs along the bottom of the block that is open about 2 inches (Figure 2). The east half of the detached block is buttressed by a bedrock protrusion that did not get shot during the previous night's blast (Figure 3). Norm and I discussed the options of removing or stabilizing the block before the next shot. I measured the dimensions and orientations of the block and indicated that I would analyze the detached block for needed reinforcement.

Figure 1. A photograph showing the detached block (red line) and the bedrock protrusion (blue line). The dashed red line assumes the tension crack continues behind the bedrock protrusion.

I drove back to the Hyak office to run analysis for the detached block. The required reinforcement to stabilize the detached block is around 87 kips and could be accomplished with 2 Type L rock bolts (50 kips each). Norm indicated that since the block is so large he would prefer that the reinforcement is spread out across the detached block. Norm requested that we locate 4 Type L rock bolts across the block and only tension them to 25 kips each. I called Brad and he requested that we locate the rock bolts at 7:00 am the following morning so we did not hold up the contractor.

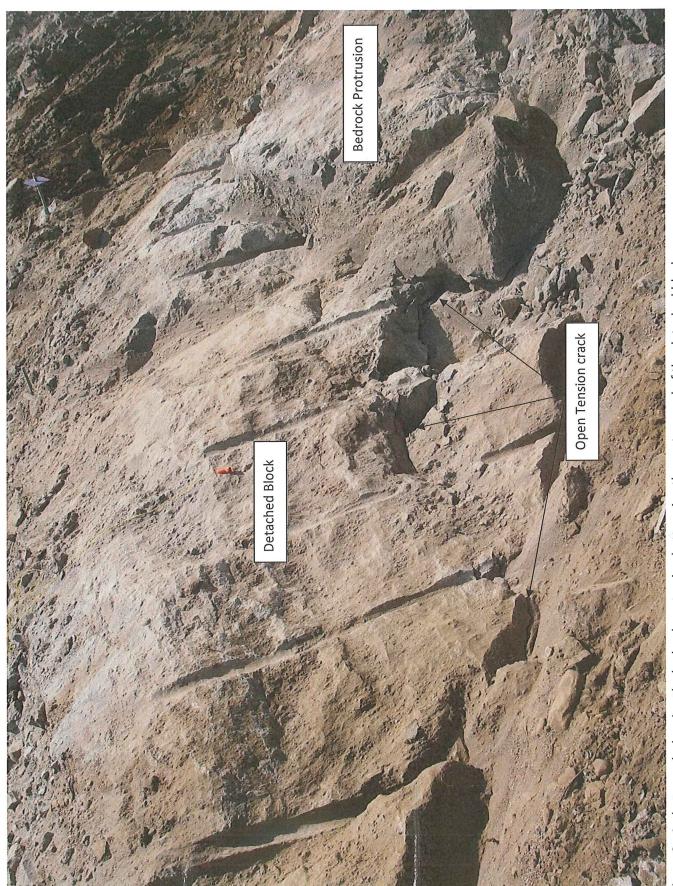
Figure 3. A photograph showing the bedrock protrusion buttressing the eastern end of the detached block.
